## **FACT SHEET**

### **Hurricane Marie Impacts to the Santa Monica Beach**

*Site conditions documented September 8-10, 2026*

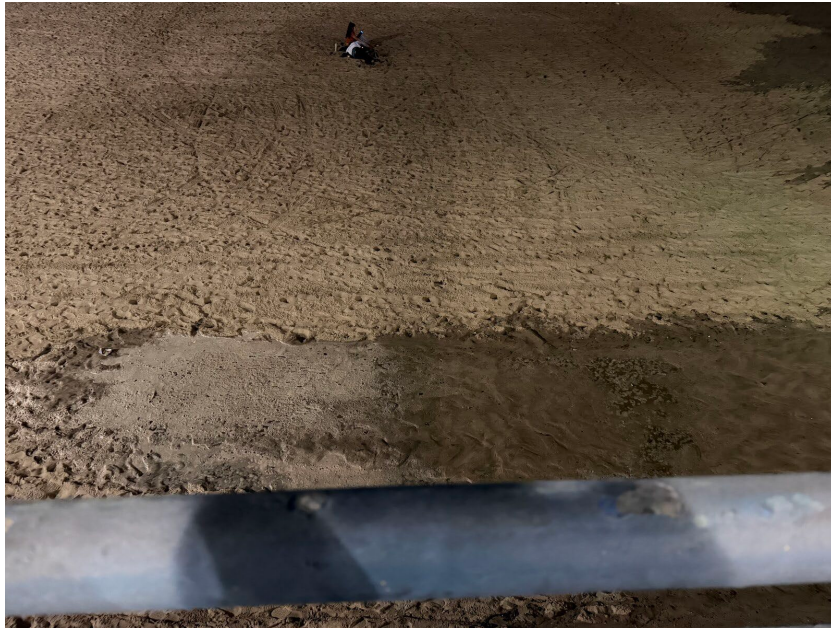
**Exhibit E**  
**Photograph, September 8, 2026, 7:52 PM**

Photo taken from the south railing of the Pier approximately 15 feet east of the Lampost 1 (see Exhibit G).  
Wet sand from high tide is visible at that location (~96 feet landward of the original festival edge.)

- **Documentation.** On the evening of September 8, the tidal run-up was documented from the Pier. At 7:52 PM, the run-up reached approximately 96 feet landward of the original production road and fire lane. A second photograph at 8:02 PM shows the run-up extending along the length of the festival site.

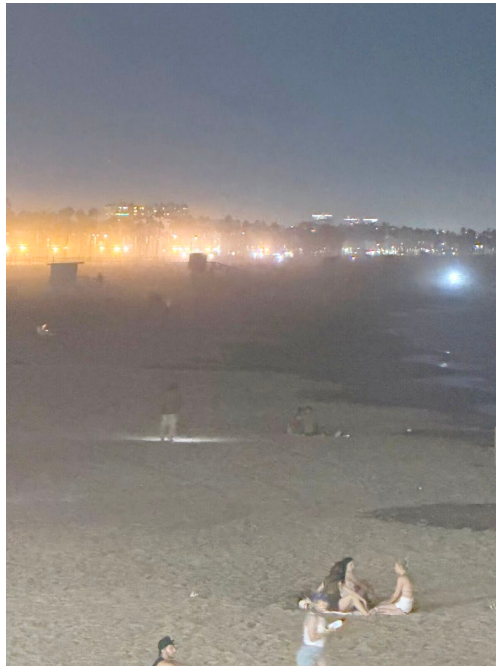
**Exhibit F**  
**Photograph, September 8, 2026, 8:02 PM**

Photo taken from the Pier at Lampost 1 (see exhibit G), looking south along the beach.  
The wet band of the tidal run-up is visible on the seaward side, extending along the length of the site.

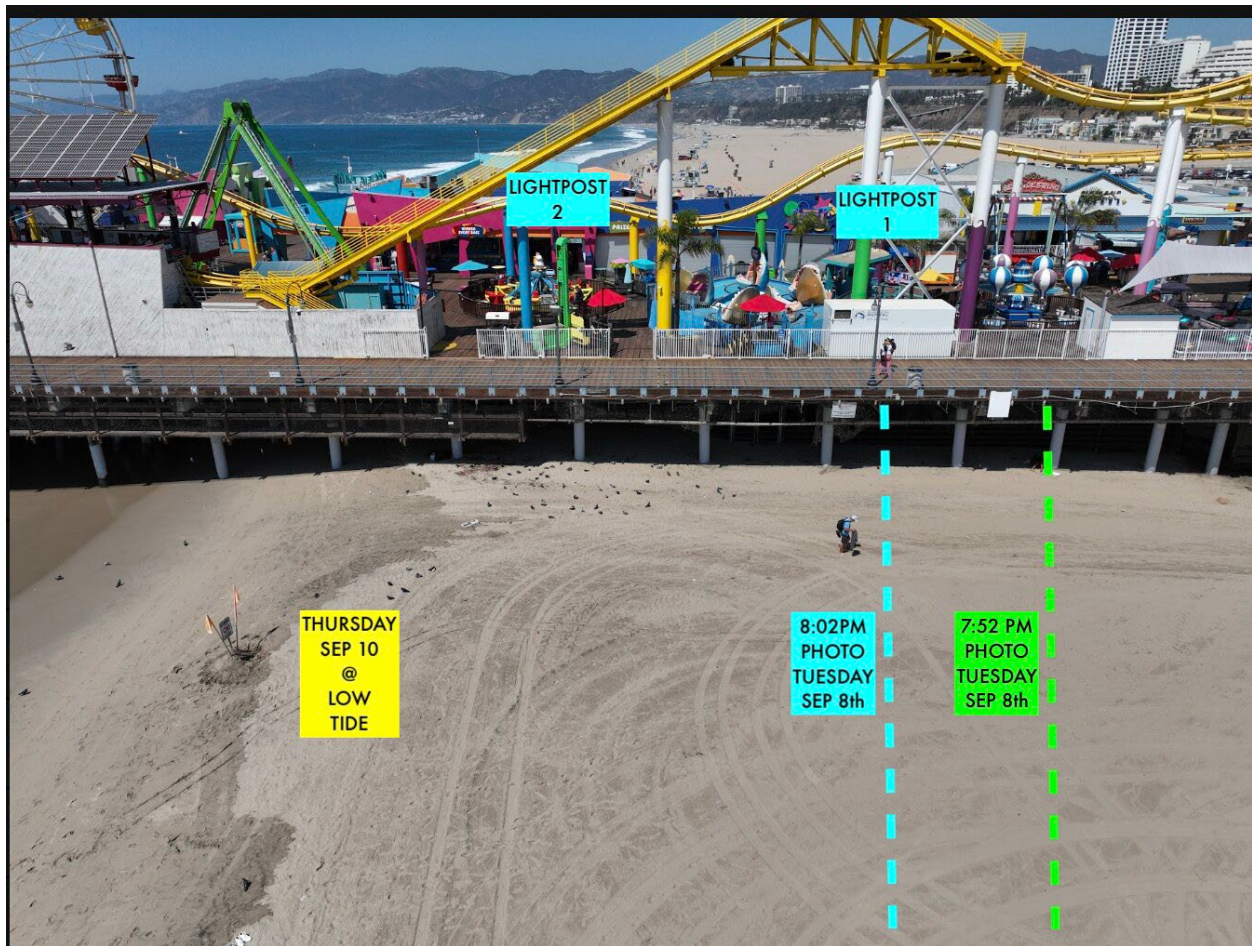
**Exhibit G**  
**Drone photograph taken September 10, 2026, at approximately 3:00 PM**

Pier Lampposts 1 and 2 are labeled.

Lamppost 2 marks the approximate location of the original festival production road and fire lane.  
The dashed blue and green lines mark the locations of the September 8 photographs (Exhibit E & F).

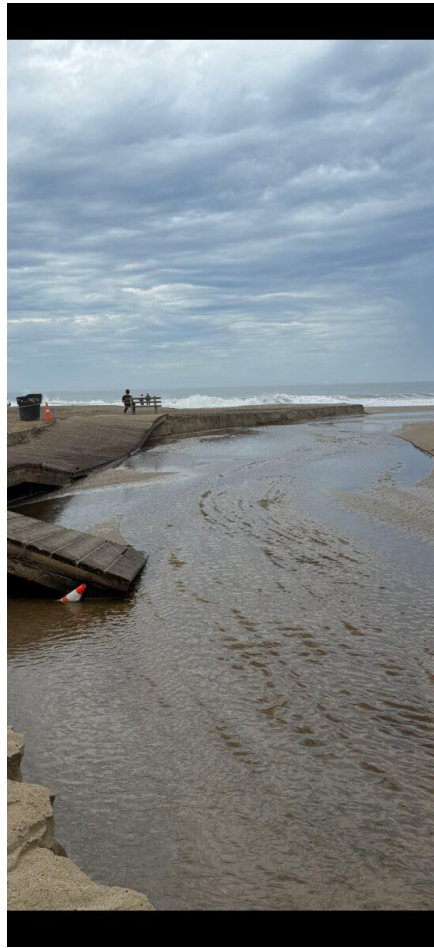
### **Exhibit H**

#### **Erosion shelf at the Pico-Kenter Storm Drain outfall channel, south end of the site**

Approximately four feet of sand removed by the storm, leaving a vertical shelf. Shelf illustrates the volume of sand removed from the festival site by the storm.

- Stormwater from the September 6 and 7 rains discharged through the Pico-Kenter Storm Drain outfall and scoured a channel across the southern portion of the site, undermining an existing beach access ramp.
- The festival's main entrance line was planned for that area, and avoiding the channel area damaged by the storm drain outfall required relocating the festival's southern boundary approximately 500 feet to the north.

Santa Monica State Beach is open and safe for everyday use. The Santa Monica Pier was not damaged and did not close. Further, the City's Public Works crews have begun repair work, including restoring the beach profile south of the Pier; stabilizing the Pico-Kenter Storm Drain outfall channel; and preparing the shoreline for the winter season.
